Complex Distal Radius Fracture Treatment Using Plate Fixation

Case Study

A 61-year-old female with a complex fracture of the distal radius was treated with the Acu-Loc 2 Wrist Plating System.

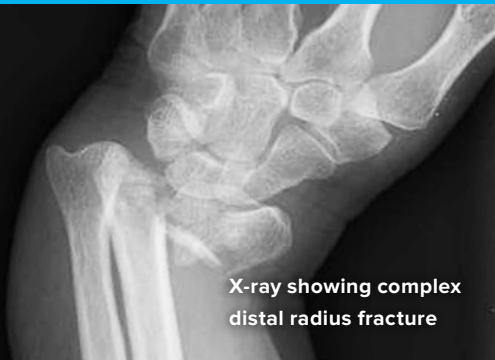
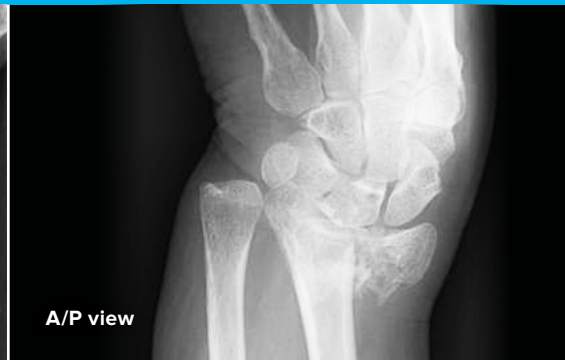
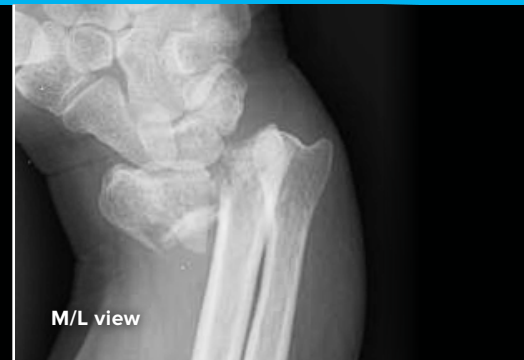
The patient is a 61-year-old female who sustained a complex distal radius fracture after falling from a step. She was initially seen in an emergency department, where a reduction was attempted. The patient was referred for definitive treatment. Given the complex, intra-articular nature of the fracture, operative intervention was recommended. Surgical options included external fixation, spanning wrist plate, or volar distal radius plate fixation.

As volar plate application was anticipated, a volar approach was used. While there was a significant amount of comminution present, the multiple fragments were each of sufficient size to accept a locking screw, and an Acu-Loc 2 plate was applied.
